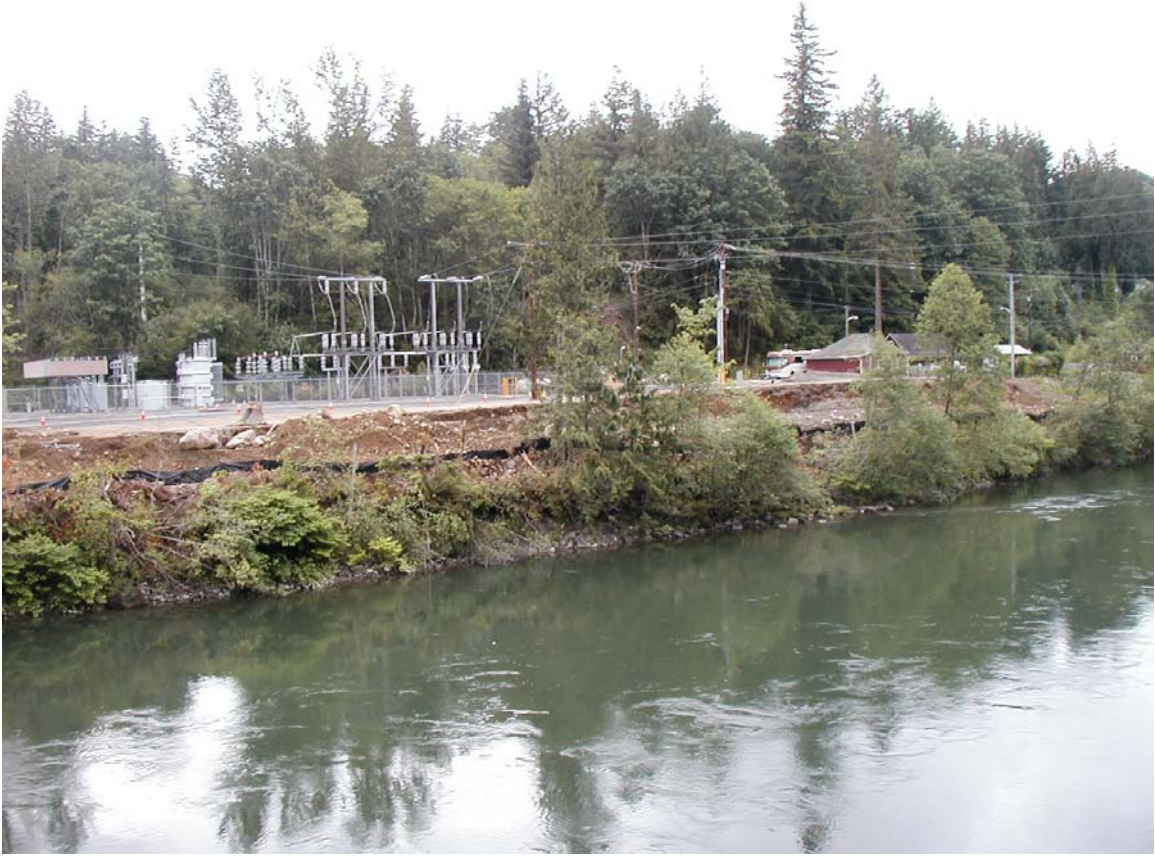
Upper-bank materials are being removed along the left bank of the river. The black line across the bottom of the excavation is a silt fence to protect the clarity of the river. Native vegetation and soil are being left intact on the lower bank at this time. Work on the lower bank is restricted to the period from July 1 to September 15, when that work is least likely to harm fish. June 10, 2004.

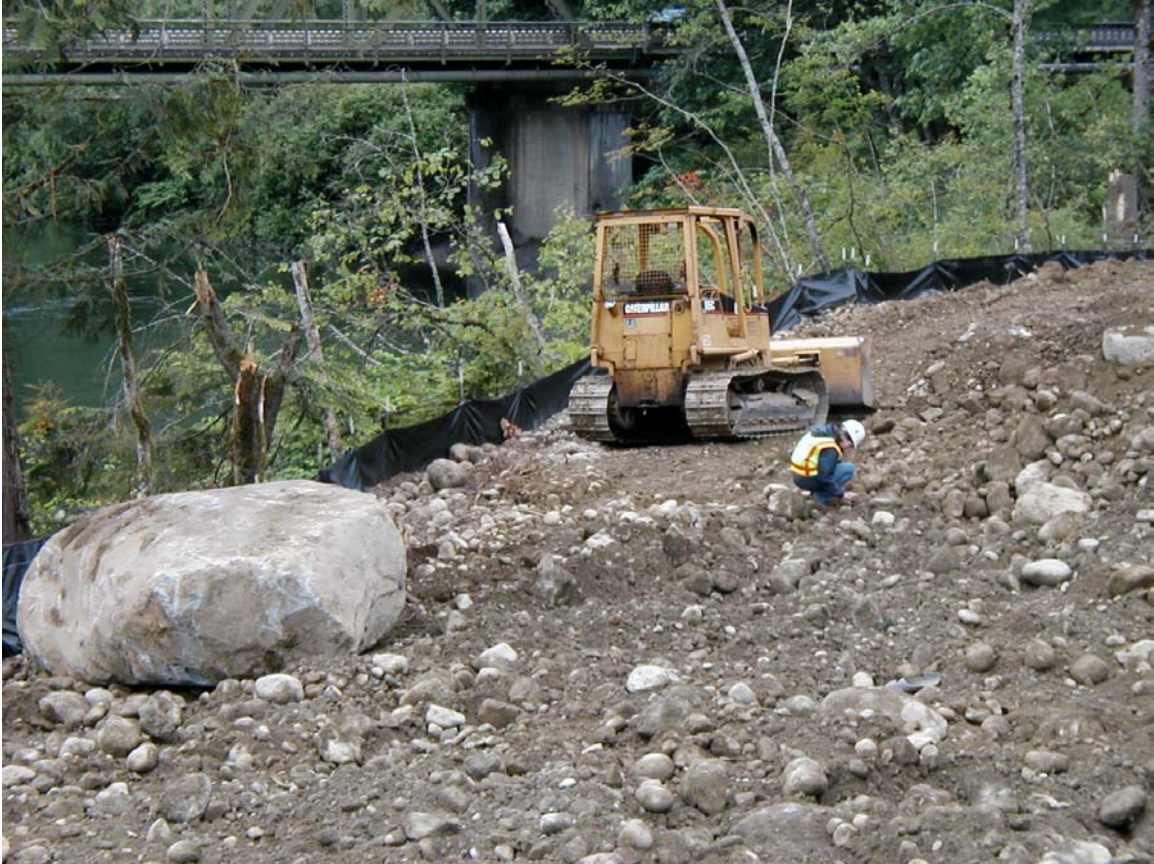
The left bank excavation includes very large boulders. In this photo, an archaeologist looks for cultural resources that might be exposed by the excavation (none have been found). June 10, 2004.

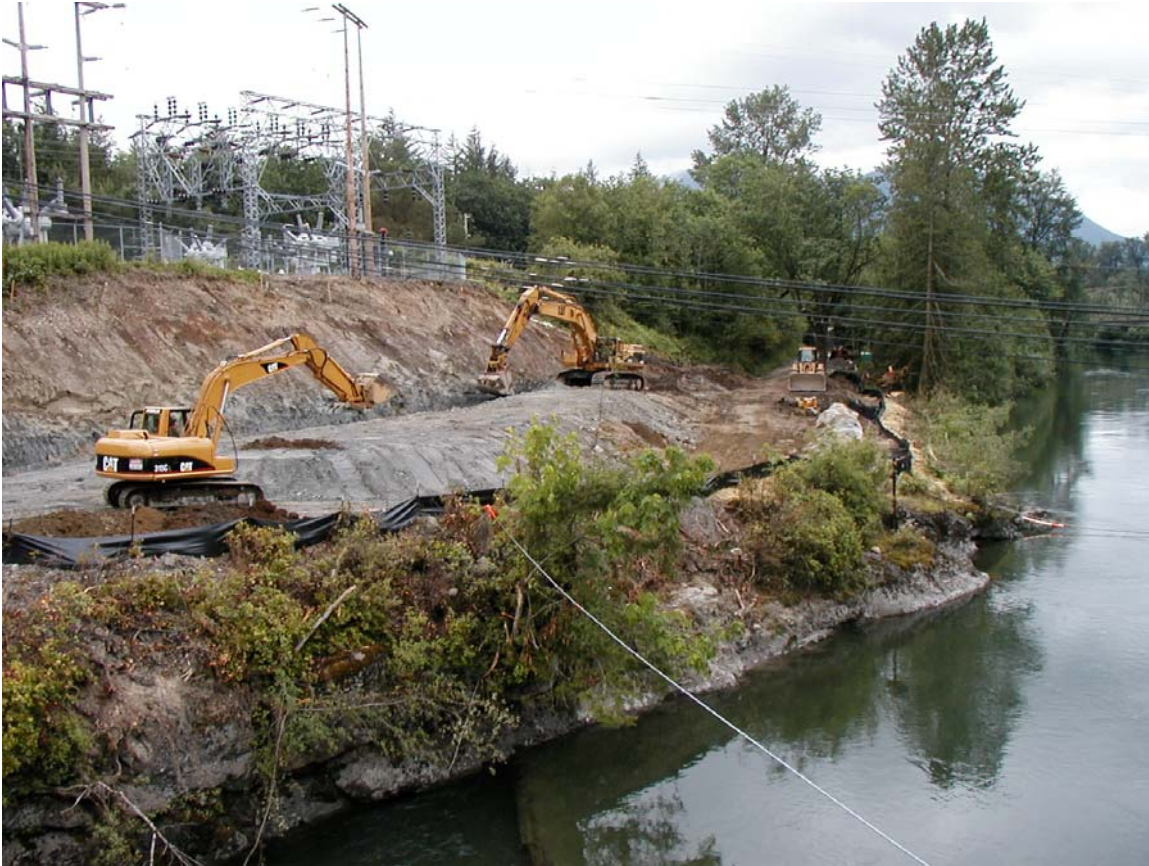
Upper-bank materials are being removed along the right bank of the river. Native vegetation and soil are being left intact on the lower bank at this time. In places, the bedrock outcropping that is visibly exposed on the lower bank extends to the surface of the excavation above. The outcropping will be removed to reduce the depth of flooding upstream. June 10, 2004.

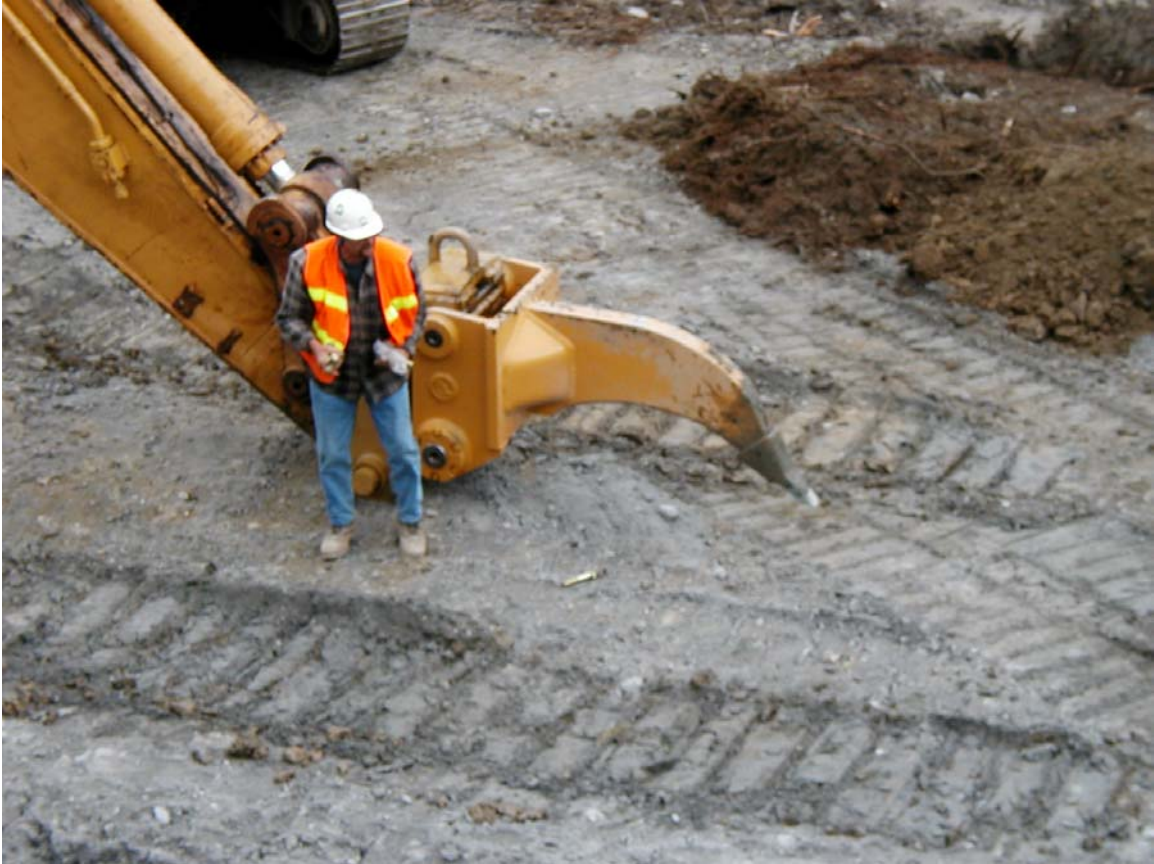
The contractor hopes to achieve the bedrock excavation with minimal (if any) use of explosives. This large ripper shank is one of several tools they are using to fracture bedrock so that it can be removed. June 10, 2004.

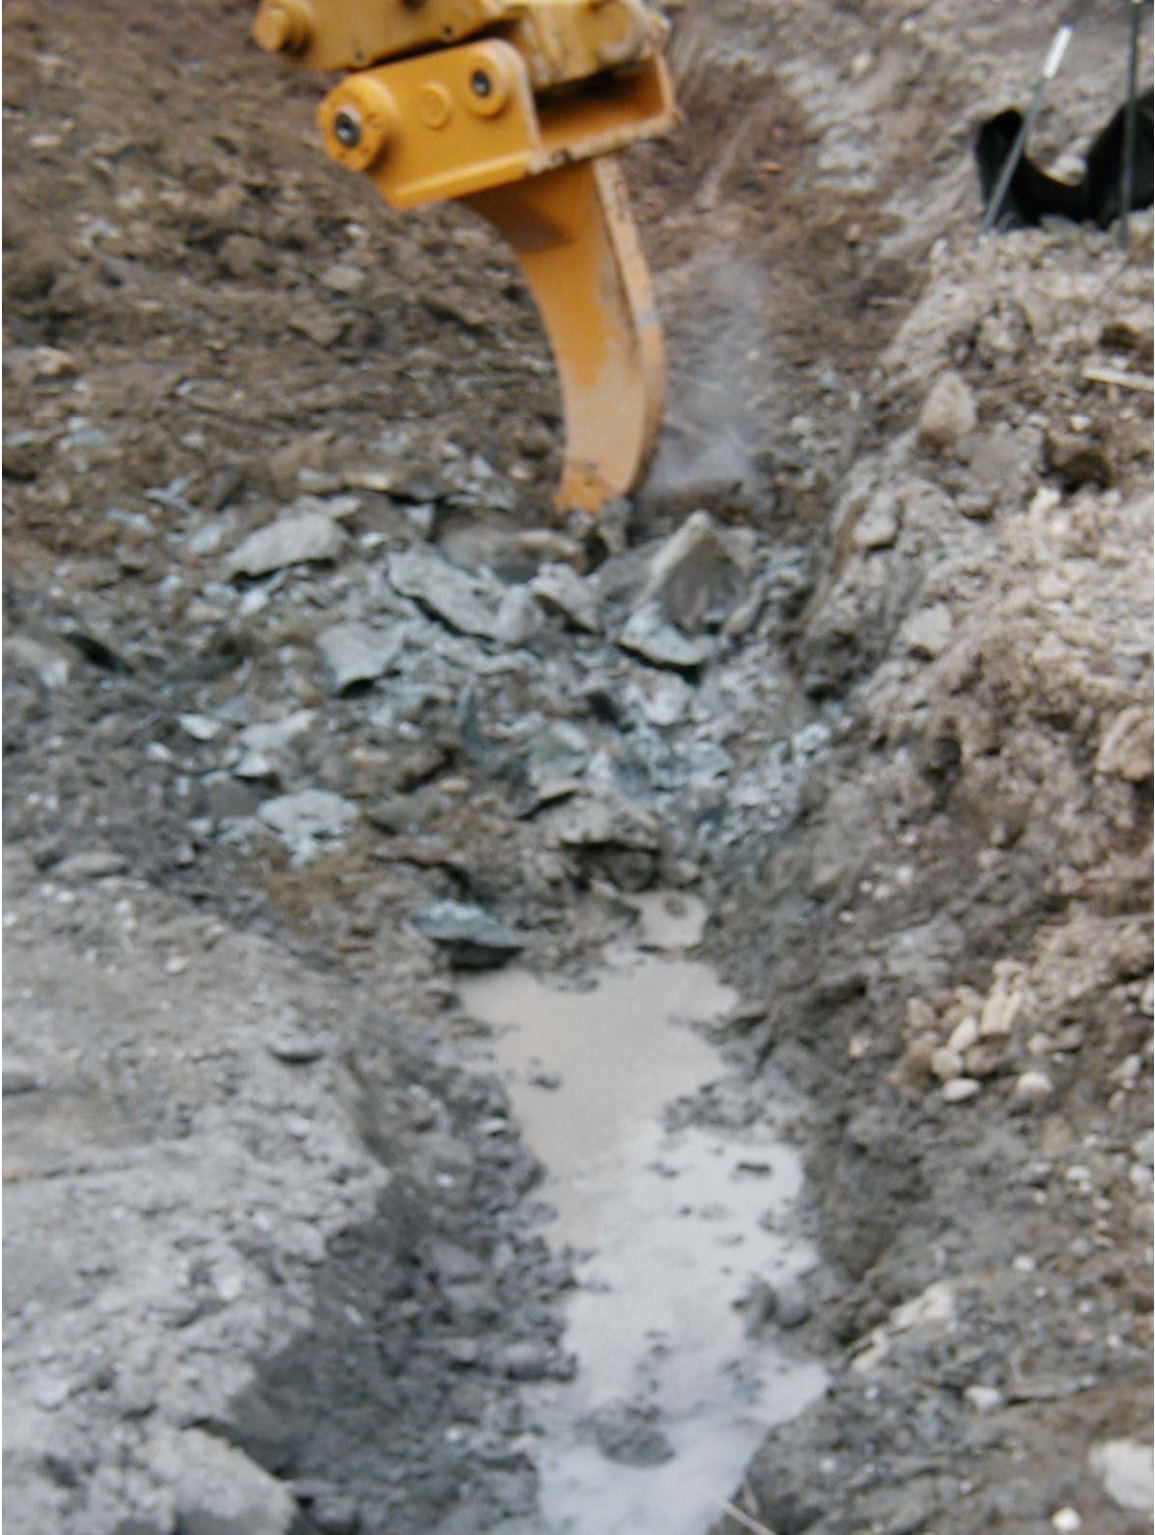
The ripper fractures bedrock in the right bank excavation area so that it can be removed. June 10, 2004.

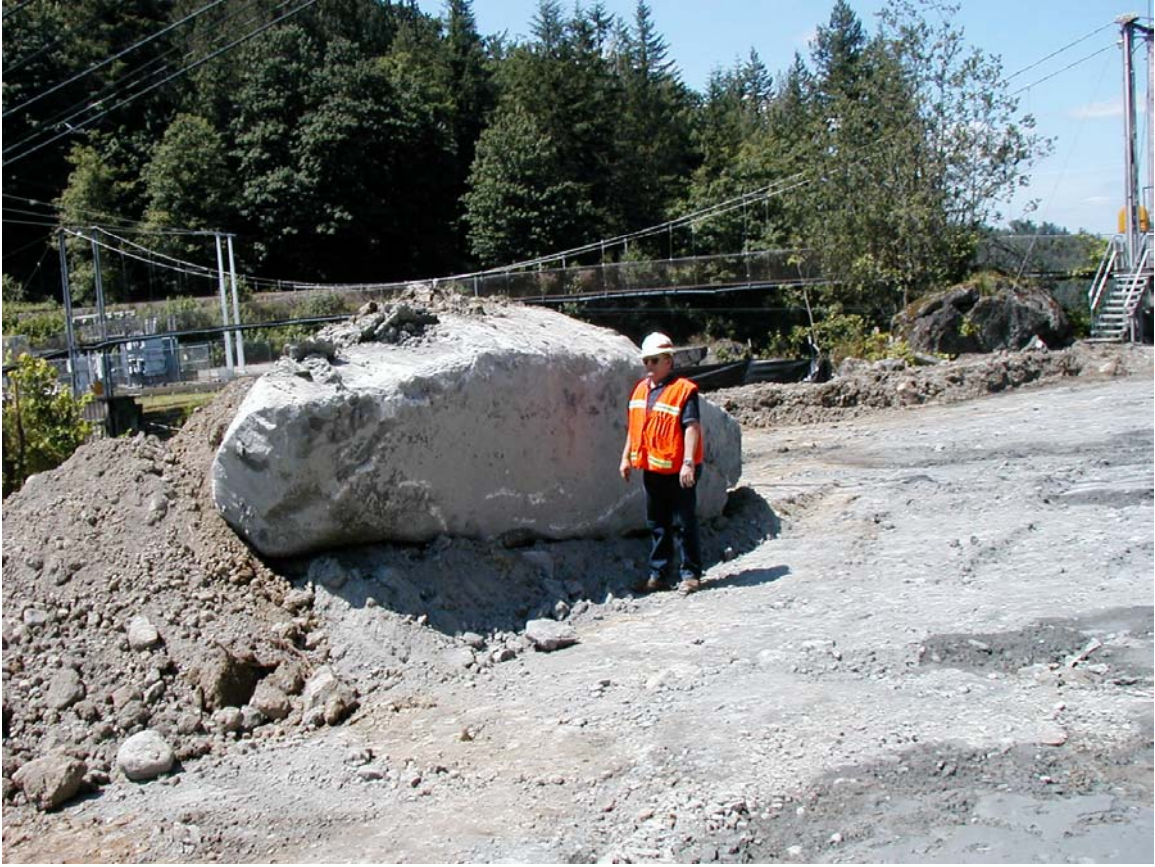
The right bank excavation includes very large boulders. Standing near this boulder is construction manager Steve Rossignol of the U.S. Army Corps of Engineers. June 8, 2004.
